## Case 321 : Narrative

Case Vehicle (A): 2001 Ford	Vehicle (B): 1994 Ford
Type: F-150, 4-door, 4 x 4 pickup	Type: Econoline E-150, 4 x 2 cargo van
Driver: 34-year-old male	Driver: 78-year-old male
CDC: 12-FYEW-2, 11-LBEW-2	CDC: 99-0000-0, 99-0000-0

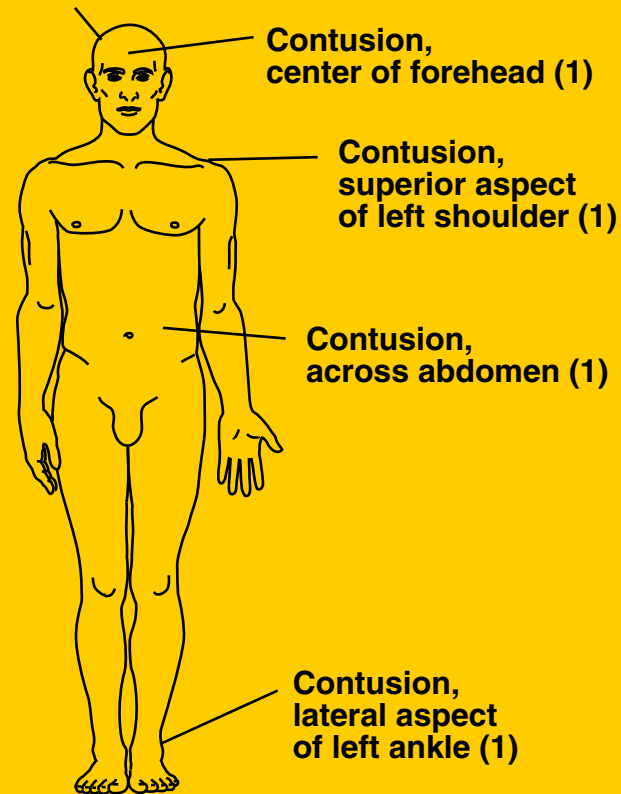
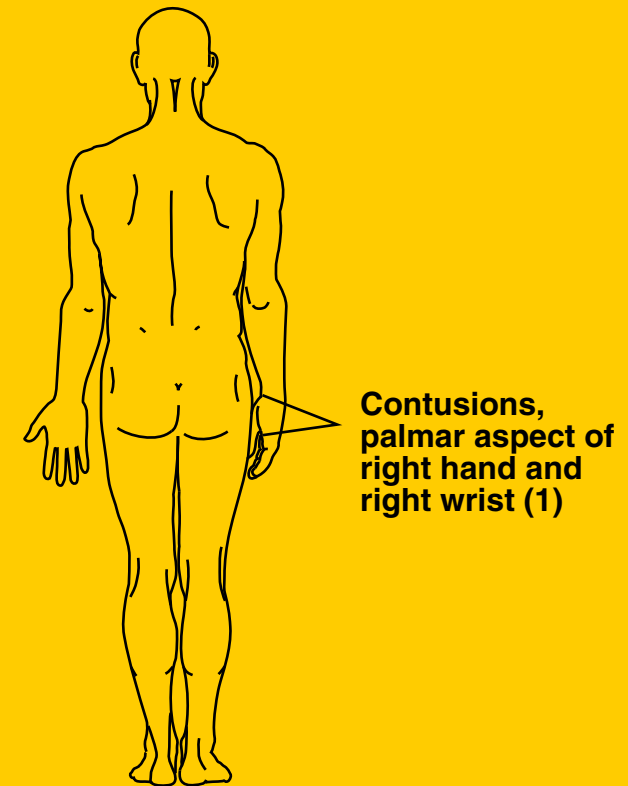
The following table and attached drawing [59](#) summarize the injuries for the driver of case vehicle (A).

Loss of consciousness  
less than 5 minutes (2)
